**PREPARED FOR:**

Wenyan Wang  
Inspection Address: 380 Colorado Ave  
Palo Alto, CA

*Inspection Date: 10/4/2021*

**INSPECTOR: CRAIG MOORHEAD**

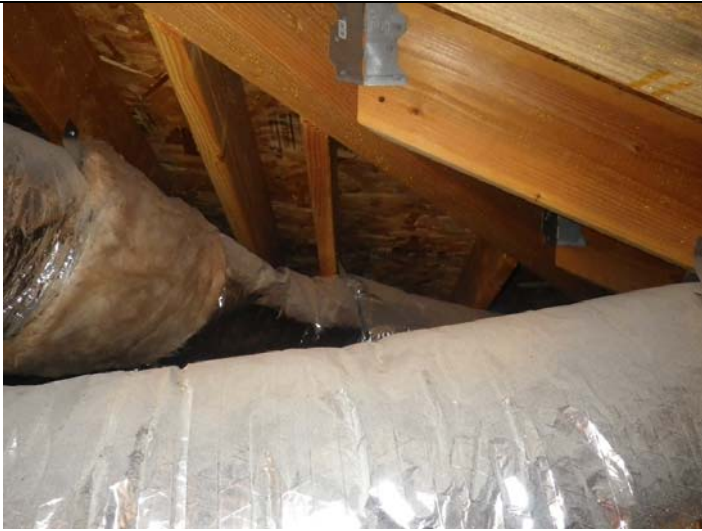
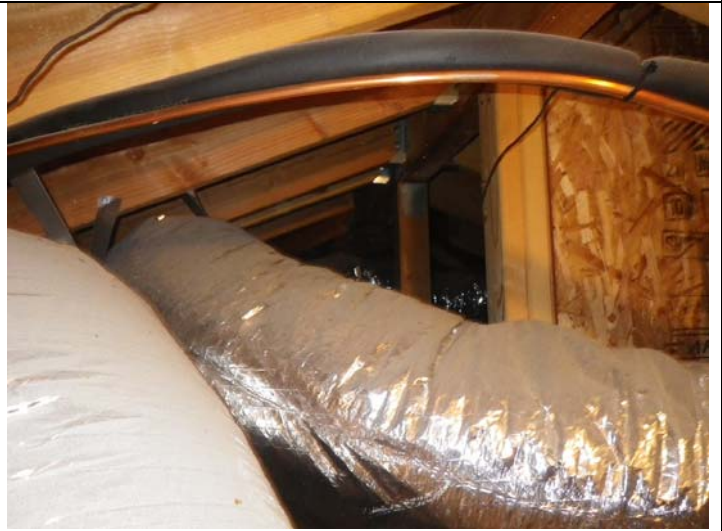
*The general attic was examined during the course of inspection, however, very limited access was noted because of small physical clearance , insulation , ducting and mechanical equipment. (See figures # 1, 2)Conventional 2X wood framing was generally visible at the roof / ceiling structure. (See figure # 3)The walls appeared to be conventional 2X wood framing installed generally.*

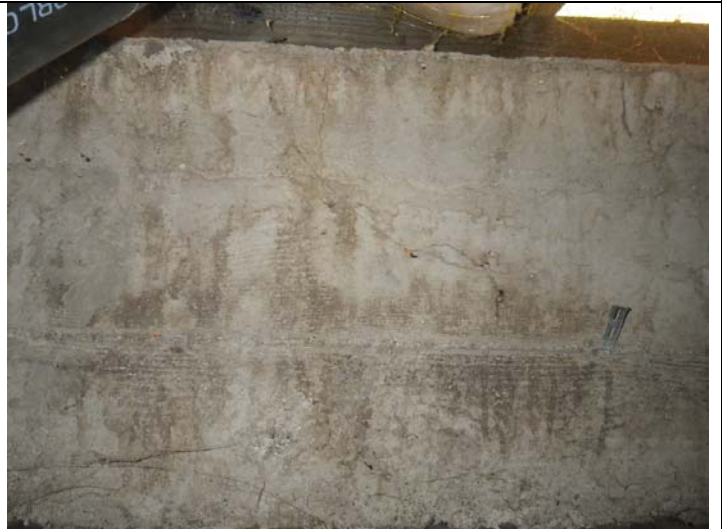
Figure 4(# 2154)

- 4.1. The general condition of the foundation appeared to be good/serviceable. Hairline / small cracks were visible in the concrete when examined, however, this is common for the age and no unusual settling was detected in the foundation when examined. (See figure # 4)

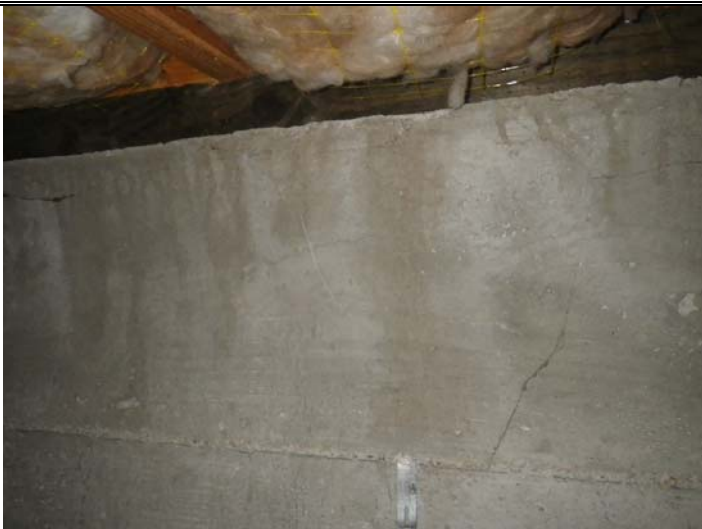
Figure 5(# 2156)

- 4.2. To hairline/small horizontal cracks each up to about 12 inches in length were visible noted at the interior foundation and was noted near the crawlspace access scuttle location. While the cause of the cracking was not determined, it may be related to the steel reinforcement at the interior of the stem wall corroding (and therefore expanding), thus cracking the concrete. Interested parties should refer to a qualified engineer for more detailed information and opinions. Since this house is less than 10 years old and under an umbrella of a structural warranty, coordination with the builder and/or builders engineer would be prudent. (See figure # 5)

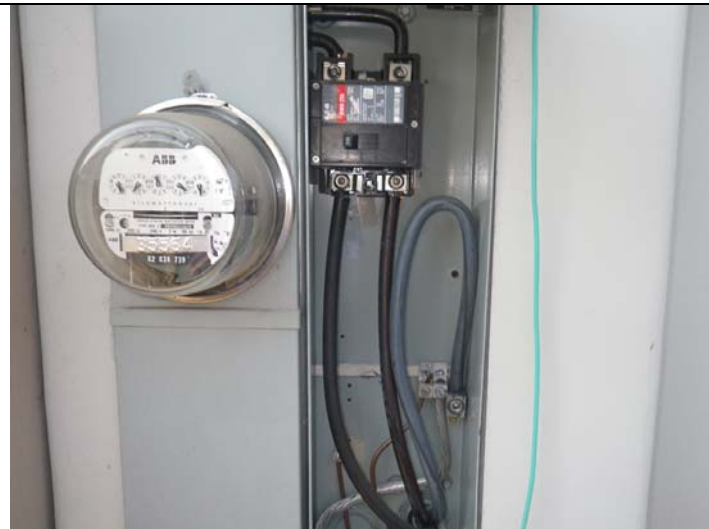
Figure 7(# 2142)

*The size / amp capacity of the main electrical panel was 200 with circuit breaker over current protection device(s) installed. The ratings were determined by markings on the panel and/or disconnect. The type of wiring installed in the panel was generally grounded non-metallic sheathed cable where visible. The installed distribution wiring servicing the 220 volt circuit(s) appeared to be generally multi-strand aluminum where visible. While previous problems pertaining to aluminum wiring have been documented including overheating due to loose connections, it generally relates to solid strand aluminum wiring. Aluminum wiring has been, and currently is generally allowed by electrical code standards to be installed. In modern installation, it is common practice for multi-strand aluminum wiring to be installed in larger diameter applications (commonly 40 to 50 amps and larger). Specific procedures including anti-oxidant paste at the connections are generally included in current / modern aluminum installations. No opinion has been rendered by this inspector or our company regarding the general decision by the builder to install aluminum wiring. Our opinions are offered and limited to the condition of the installed system as ascertained by visual inspection. In-depth inspection of the system was not performed. For more detailed inspection regarding the wiring installation, you should contact a licensed electrical contractor. For more specific information regarding aluminum wiring installation contact a licensed electrical contractor and/or the local consumer protection agency. Grounding conductors in the main panel were visible. Bonding (connection of the ground) of the panel was noted when inspected. Access for inspection of the panel included examination behind the dead front / face plate. (See figure # 7)*

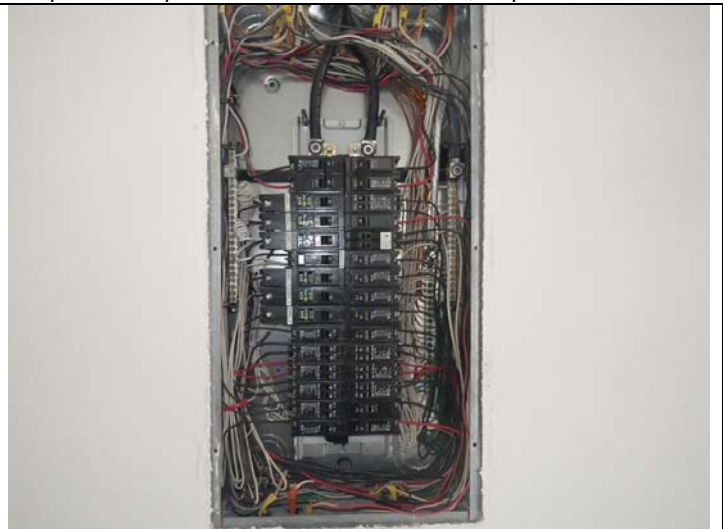
Figure 8(# 2140)

*An electrical sub-panel was installed. Over current protection at the branch circuits was provided by circuit breakers. The method or type of wiring installed was generally grounded non-metallic sheathed cable where visible. The installed distribution wiring servicing the 110 and 220 (120/240) volt circuit(s) appeared to be generally copper where visible. An AFCI (Arc Fault Circuit Interrupt) breaker was noted at the panel. AFCI's are a safety device and should be tested monthly for proper operation. To test the device, push the test button and verify that power was turned off to the locations protected by the AFCI (originally bedrooms but current standards require all receptacles other than GFCI's to be AFCI protected). Access for inspection of the panel was good and visual inspection included removal of the dead front face plate. (See figure # 8)*

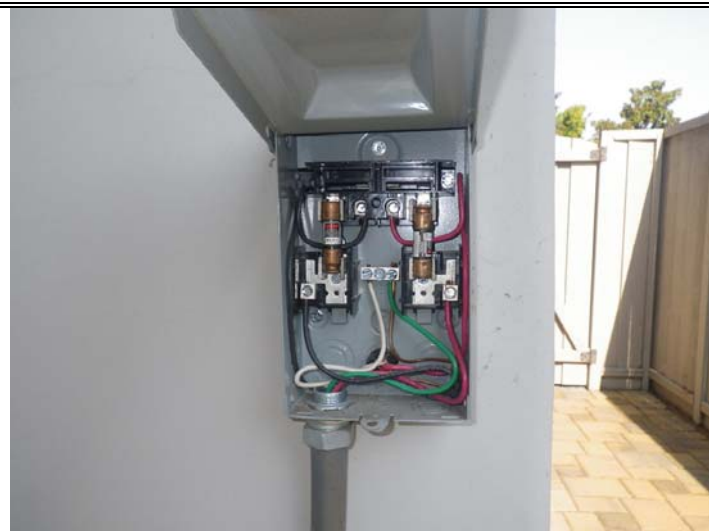
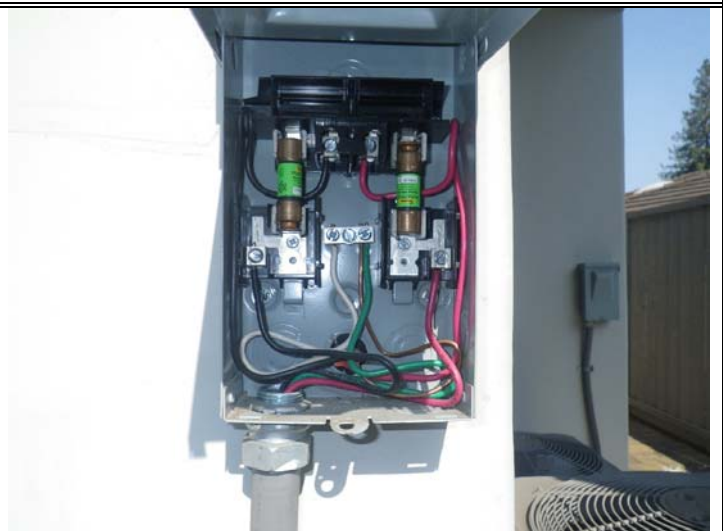
*Electrical disconnect panels were installed at the back left and were servicing the nearby air-conditioning equipment. (See figures # 9, 10)*

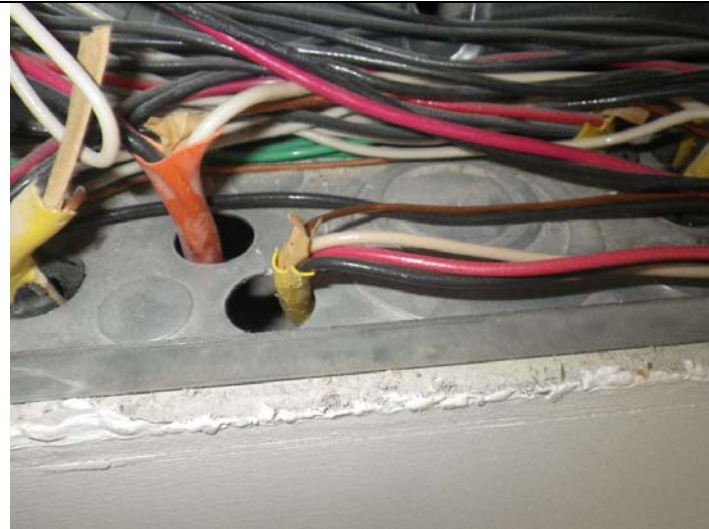
Figure 11(# 2141)

13.3. Sub-panel (garage): Wiring was noted which was not secured / clamped to the panel box at the entrance to the panel. Securing the building wiring at this location is standard practice and is intended to protect the wiring connections and/or sheathing from movement. Have a licensed electrical contractor repair as needed. (See figure # 11)

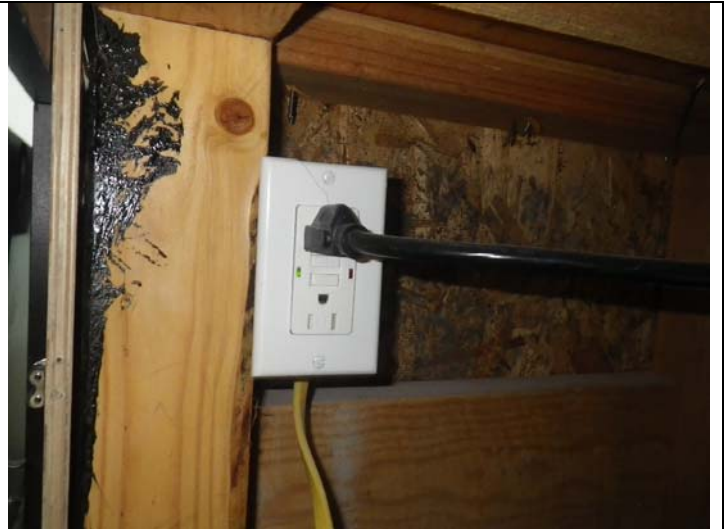
Figure 12(# 2145)

13.4. Master Bath: A GFCI electrical circuit for the whirlpool bath was found adjacent to the pump and tested to be functional at the time of inspection. This needs to be tested monthly and verified functional to provide / maintain safe operation of the whirlpool equipment. (See figure # 12)

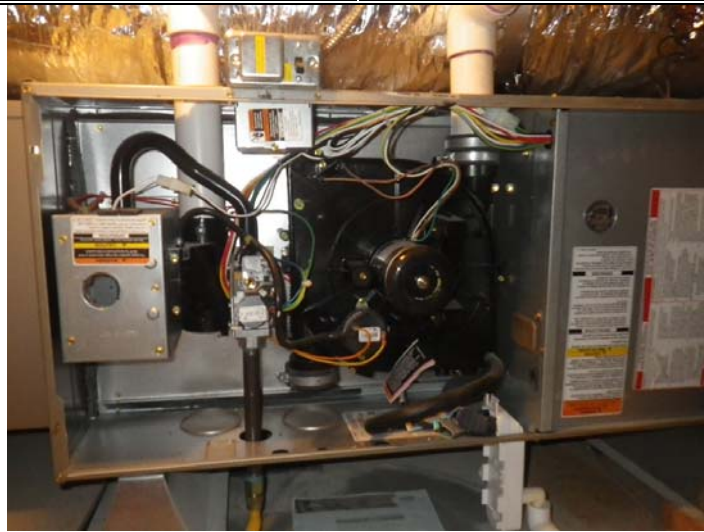
Figure 13(# 2147)

14.7. Upstairs HVAC: The furnace was visually examined at the time of inspection. Because of the nature of the units design, no access of the exchanger was noted. The unit was fire tested by modifying the temperature setting at the thermostat and appeared to be in generally serviceable condition at the time of inspection except/unless as otherwise noted. (See figure # 13)
