**PREPARED FOR:**

Wenyan Wang  
Inspection Address: 380 Colorado Ave  
Palo Alto, CA

*Inspection Date: 10/4/2021*

**INSPECTOR: CRAIG MOORHEAD**

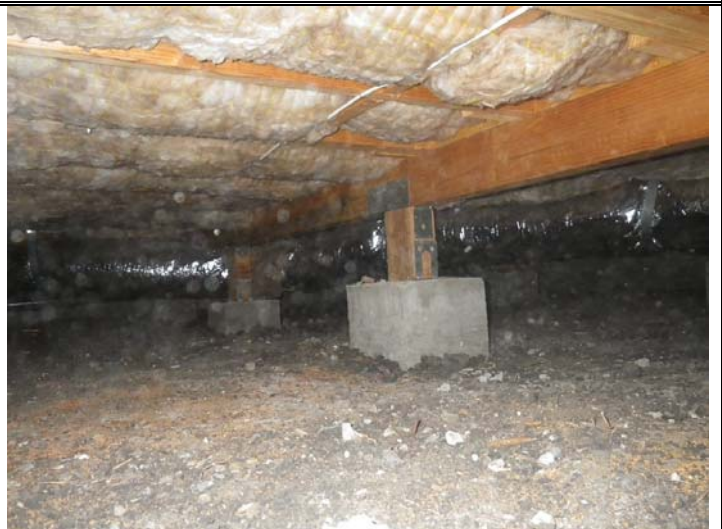
Figure 6(# 2155)

*Fiberglass blanket insulation was generally installed at the general sub-floor location(s). Floor insulation installed in current local construction would generally have R-values usually ranging around R-19. Limited access of the sub-floor and framing was noted because of the insulation. (See figure # 6) Fiberglass loose-fill insulation was installed at the ceiling/roof and appeared to have an average depth of approximately 10 to 12 (R-30). Current local standards would generally have roof / ceiling insulation with R-values usually ranging between R-19 and R-30 (with the larger "R" value indicating more insulation). While there was insufficient access to determine or verify wall insulation when inspected, there is a good chance that it was installed. Wall insulation is commonly found in houses constructed since the mid 1970's and would be very likely in houses built in the 1980's and later. Current local standards would generally dictate insulation in the walls with the R-values usually ranging between R-11 to R-13.*
